HILLSBORO INLET

INLET SUMMARY SHEET

SITE: Hillsboro Inlet, Broward County, Florida

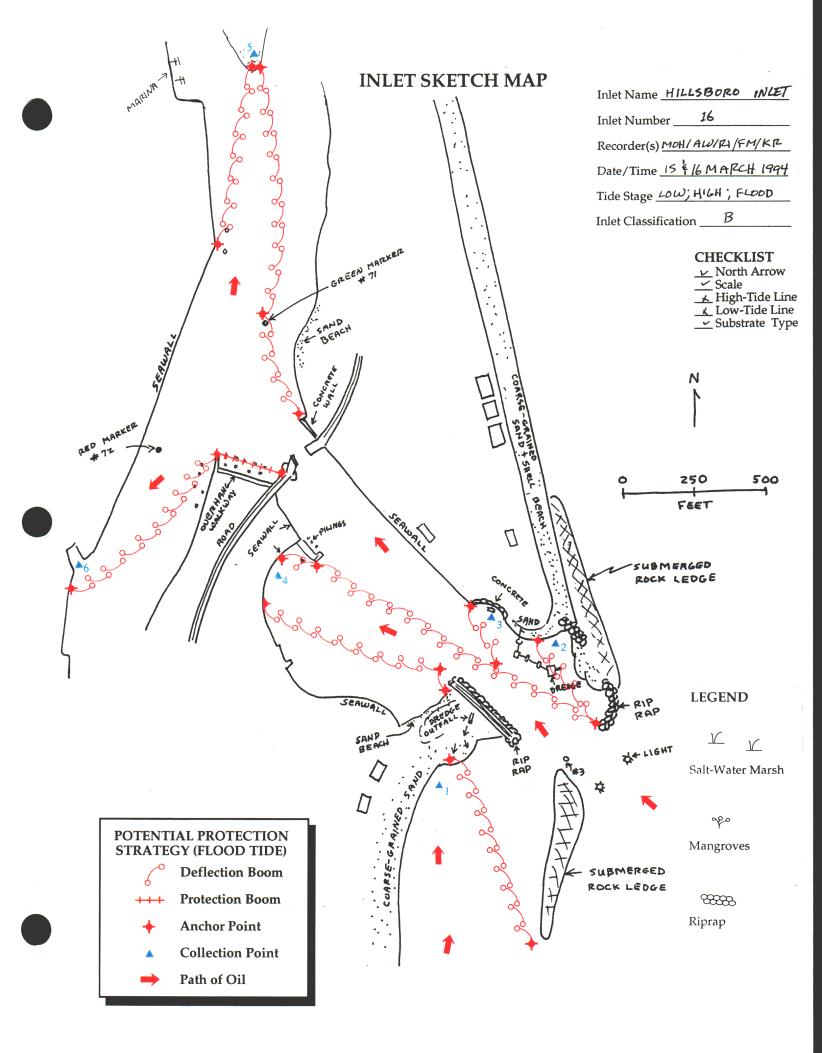
If entrainment past the Christmas tree were to be anticipated, lines of harbor deflection boom could be established north and south of the inlet in the Hillsboro River. These lines of boom would deflect oil to collection points located to the north and south (CPs 5 and 6; see sketch map).

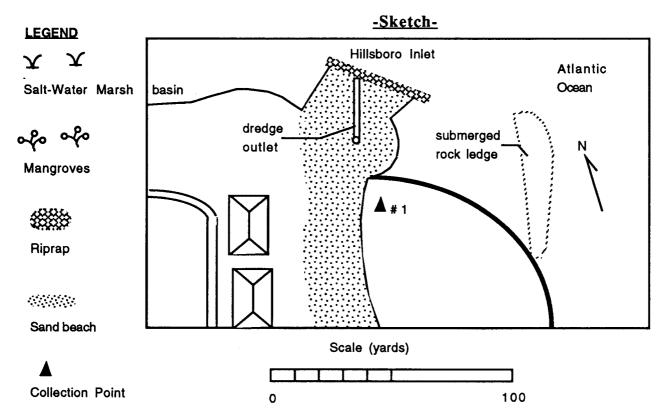
Site Name / #: South Jetty Beach Collection Site; #1

Site Type(s): Manual / Mechanical Collection

Relative Location: South Jetty outer beach.

Water Depth Description: 2' depth @ 25' off beach, 4' depth @ 50' out, 6' depth @ 75' out

Current / Tide Information: 1-3 knots maximum flood along shore, 2'-3' average tidal range.

Shoreline Description: Fine to medium sand beach (100 yards wide)

Access Description: Paved to sand for 1/2 mile to collection point. Possible to pad beach for vac truck access on beach.

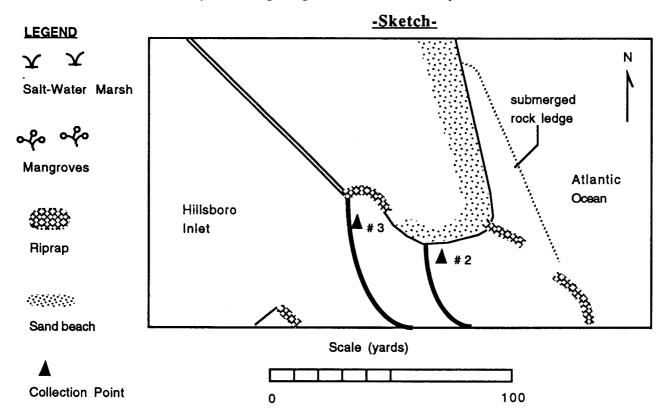
Site Name / #: North Jetty Collection Site; #2,3

Site Type(s): Mechanical Collection

Relative Location: Seath Jetty outer beach

Water Depth Description: 2' depth @ 25' off beach, 4' depth @ 50' out, 6' depth @ 75' out.

Current / Tide Information: 1-3 knots maximum flood along shore, 2'-3' average tidal range.

Shoreline Description: Fine to medium sand beach (100 yards wide).

Access Description: Paved to sand for 20' to water. Possible to pad beach for vac truck access on beach.

Support Equipment / Facilities: Water, electric, lighting.

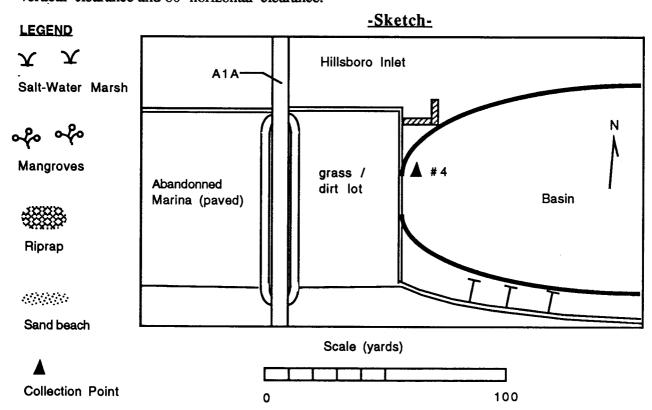
Site Name / #: South Basin Collection Site; #4

Site Type(s): Mechanical Collection, Staging

Relative Location: SE corner of Hillsboro Bridge

Additional Comments: Barbed-wire, fenced lot, locked gate with chain. Bascule bridge with 13' vertical clearance and 60' horizontal clearance.

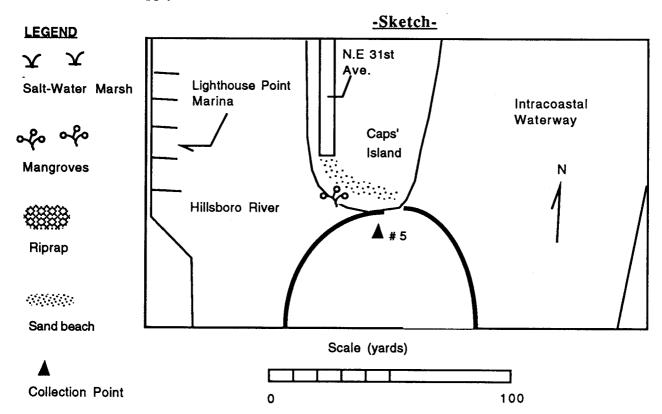
Additional Comments: Property for sale and undeveloped, adjacent marina with docks, gas, diesel, haul out, supply, food (across channel)
